TRECOM TECHNICAL REPORT 63-42

SUMMARY REPORT
HIGH-PERFORMANCE-HELICOPTER PROGRAM
PHASE I

September 1963

BELL HELICOPTER COMPANY
Fort Worth, Texas

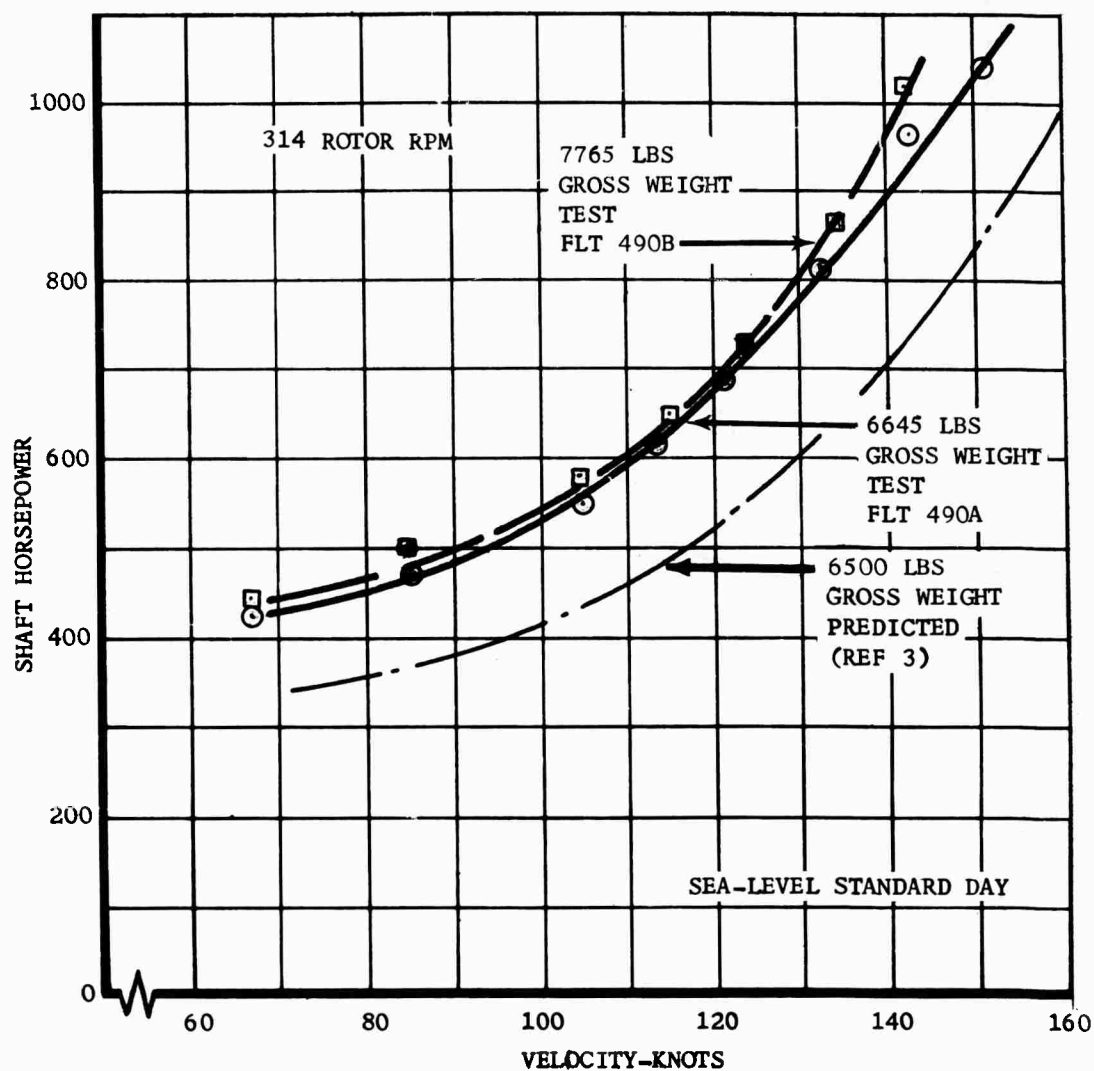
FIGURE 19 - LEVEL-FLIGHT PERFORMANCE,
THREE-BLADED GIMBALED ROTOR

Level-flight speed power data at two gross weights for each rotor configuration are shown in Figures 17 through 20. The highest speeds were attained with the two-bladed rotor without the stabilizer bar. With this configuration, 155 knots true airspeed was attained in level flight, and 162.5 knots was attained during a shallow 4-degree dive at reduced power. The maximum airspeed with the standard rotor with the stabilizer bar was 150 knots; with the three-bladed rotor, 151 knots.

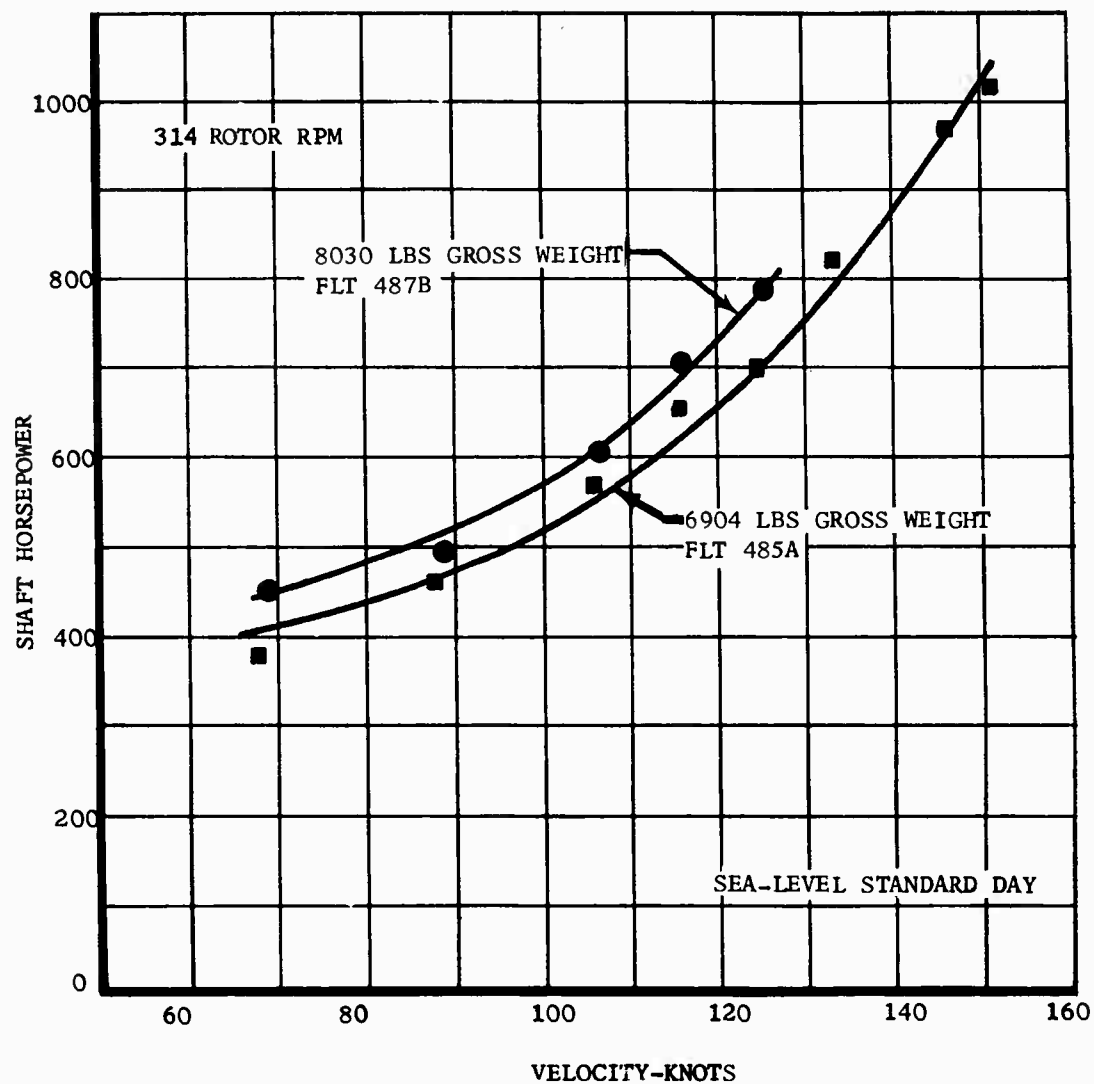
FIGURE 20 - LEVEL-FLIGHT PERFORMANCE,
THREE-BLADED RIGID ROTOR

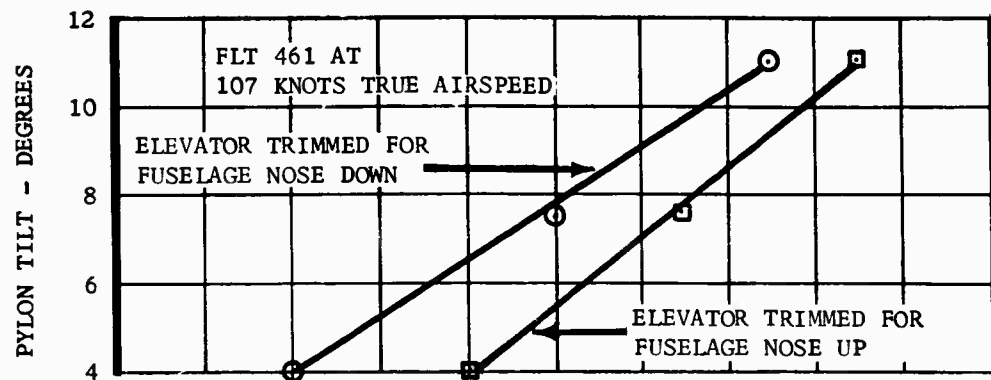
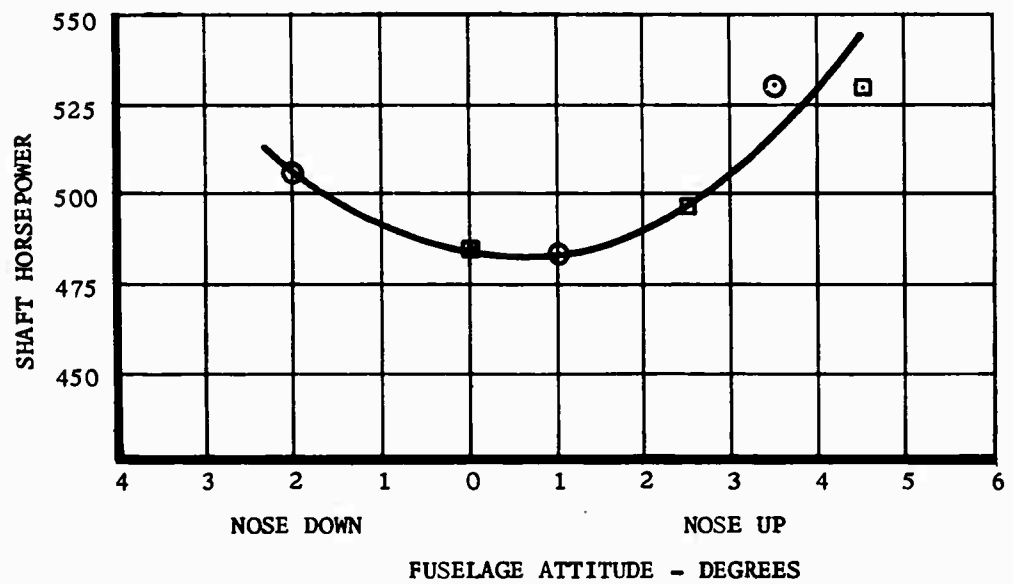
FIGURE 21 - POWER VS FUSELAGE TRIM

fuselage attitude is optimum and that a 4-degree deviation from this optimum causes a considerable power loss. At 107 knots, the optimum pylon tilt angle was found to be about 7 degrees (depending on the elevator setting); while at maximum speed, optimum results were obtained with the pylon at about 10 degrees.

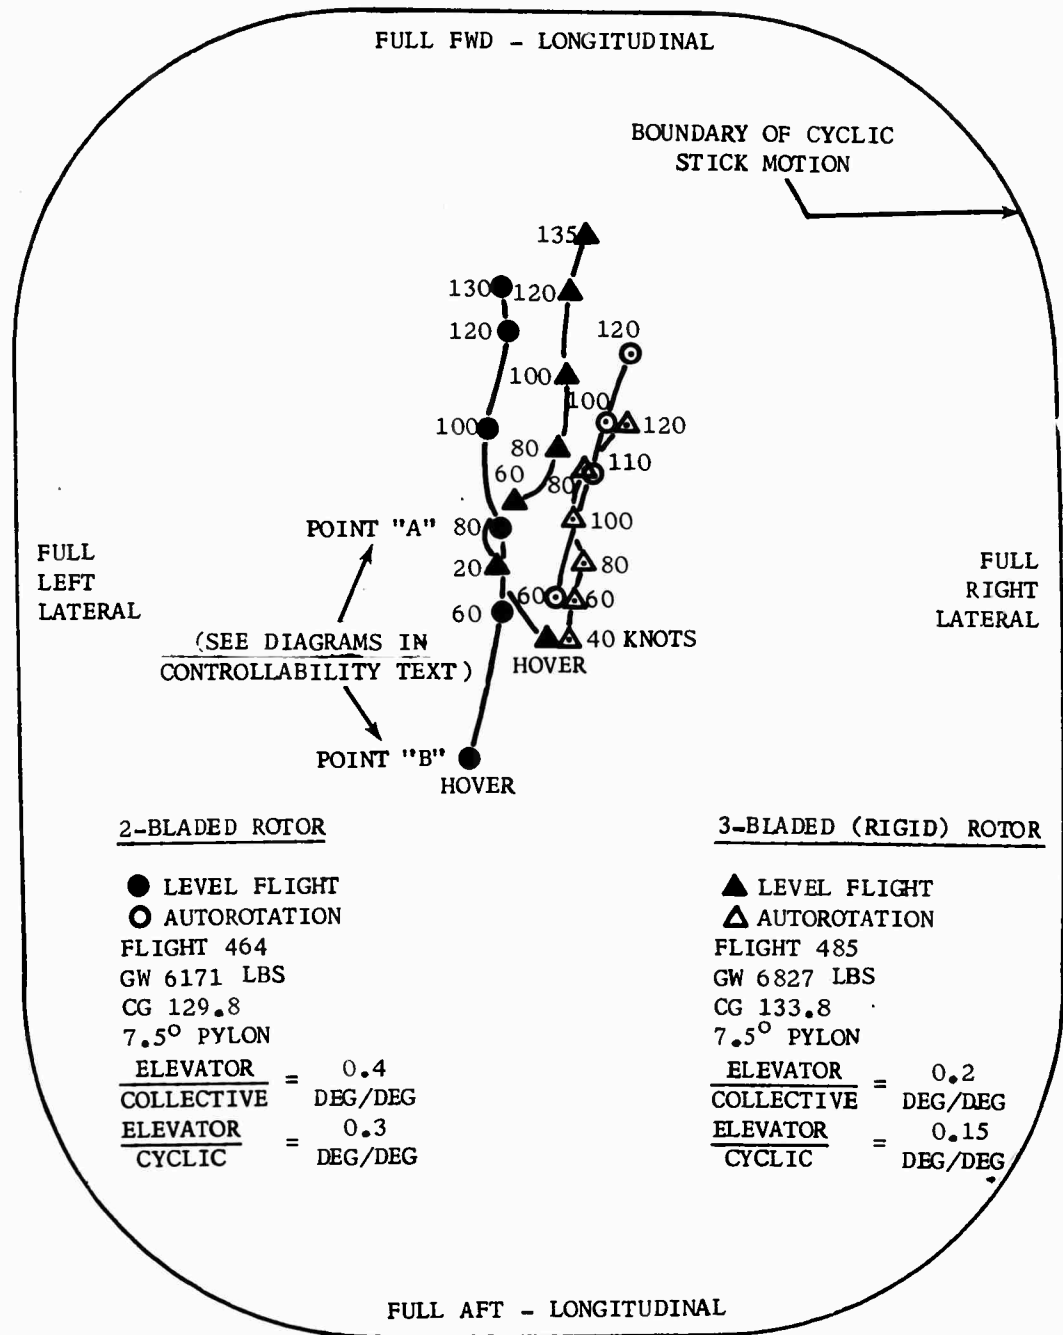
FIGURE 22 - SAMPLE STICK PLOTS

Controllability data were obtained for each of the four configurations. Figure 22 is a composite of typical stick plots obtained during the flight testing. It shows longitudinal and lateral cyclic stick position

as a function of speed for the two-bladed rotor with stabilizer bar and for the three-bladed rigid rotor. From such plots, the level-flight longitudinal controllability information can be extracted. Data for all four configurations are presented in Figure 23, and the longitudinal gradients in level flight are seen to be very nearly the same and possess positive gradients. Another longitudinal controllability characteristic to be noted is the effect of the synchronized elevator. The synchronized elevator proved to be effective in controlling fuselage attitude during forward flight (see inset at left), and showed a definite improvement over the standard installation with respect to autorotation characteristics.

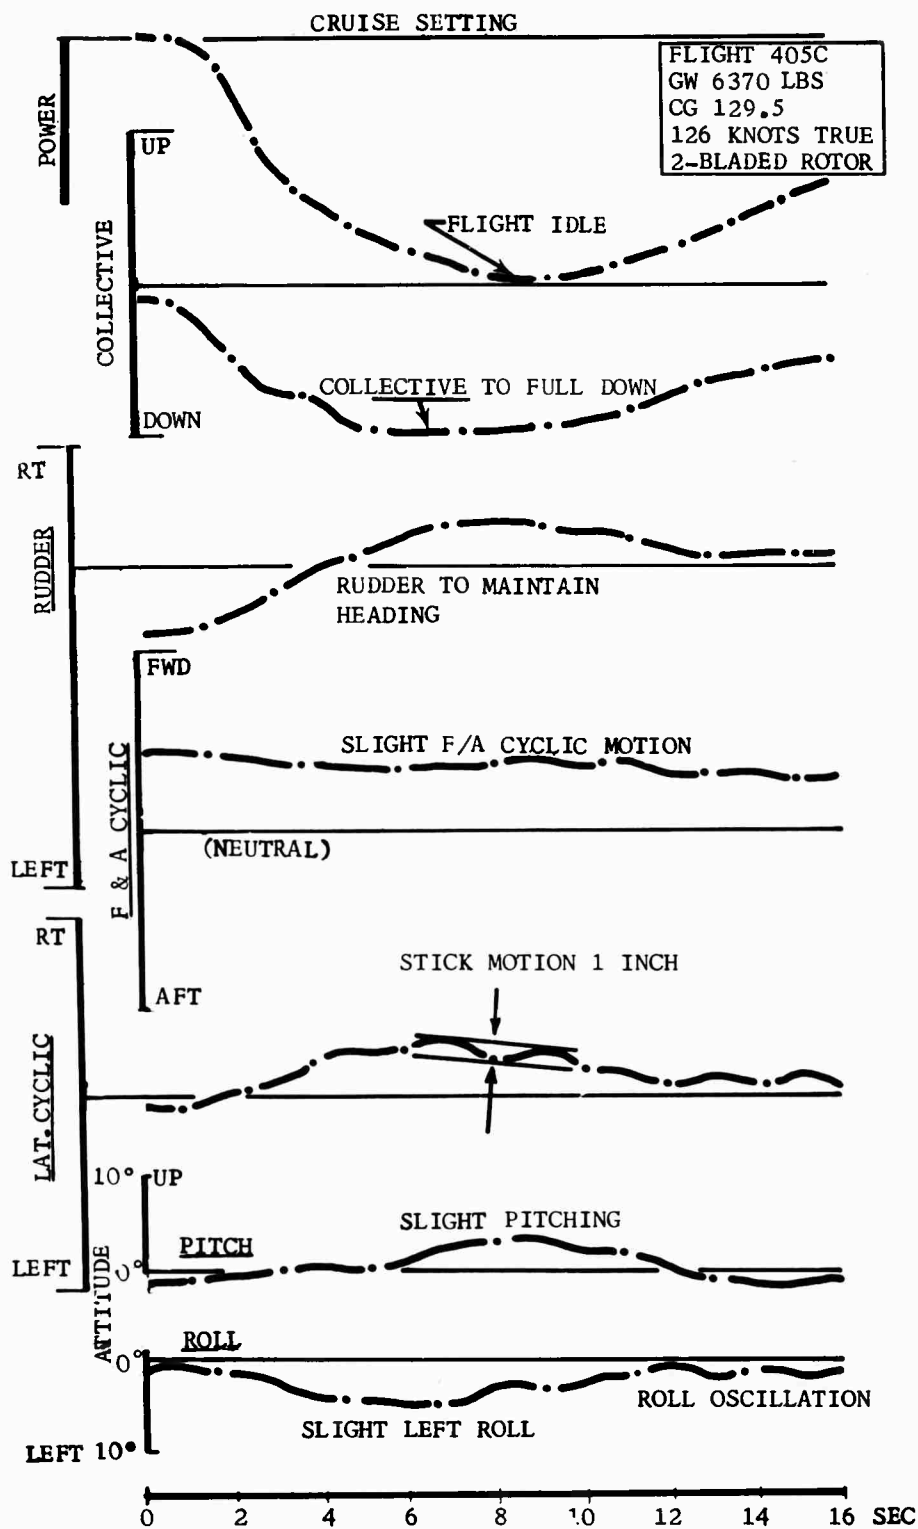
FIGURE 25 - TIME HISTORY OF AUTOROTATION ENTRY

The behavior of the helicopter during an autorotation entry at cruise speed was determined early in the test program during pilot familiarization flights because of its importance to safety. Figure 25 is a time history of the control position and fuselage response with the two-bladed rotor and stabilizer bar during a rapid power reduction from 126 knots airspeed. As shown by the figure, no excessive or abrupt control motions were required to return the helicopter to a stabilized flight condition. The power reduction was accomplished primarily by decreasing main-rotor collective pitch. The fore-and-aft cyclic stick position change that is normally required when entering autorotation has been virtually eliminated by the use of the synchronized elevator. The roll attitude trace shows the left rolling tendency and the oscillatory nature of the roll response.

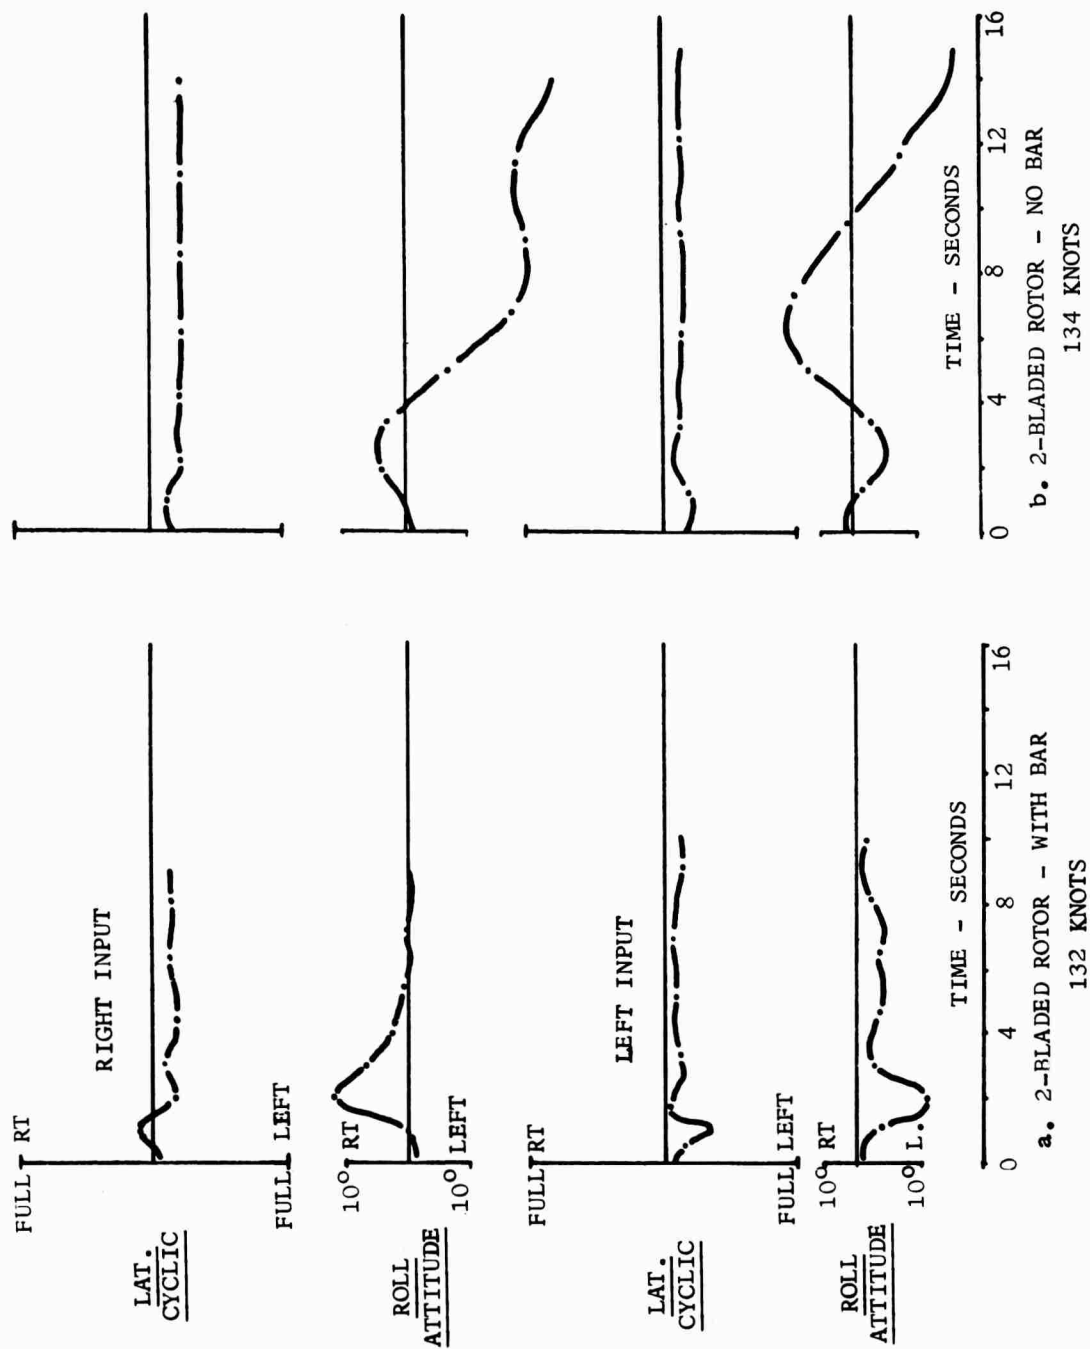
FIGURE 26 - DYNAMIC STABILITY - LATERAL CONTROL INPUT.

- Lateral Control Pulse - Figure 26a shows the high-performance-helicopter roll response with the standard rotor and stabilizer bar at 132 knots in level flight. The left rolling tendency mentioned earlier is not apparent in this figure. The improvement in roll characteristics at this speed is believed to be the result of fuselage and rotor interference effects. A general deterioration of roll stability takes place with increased speed due to the reduction in rotor damping.

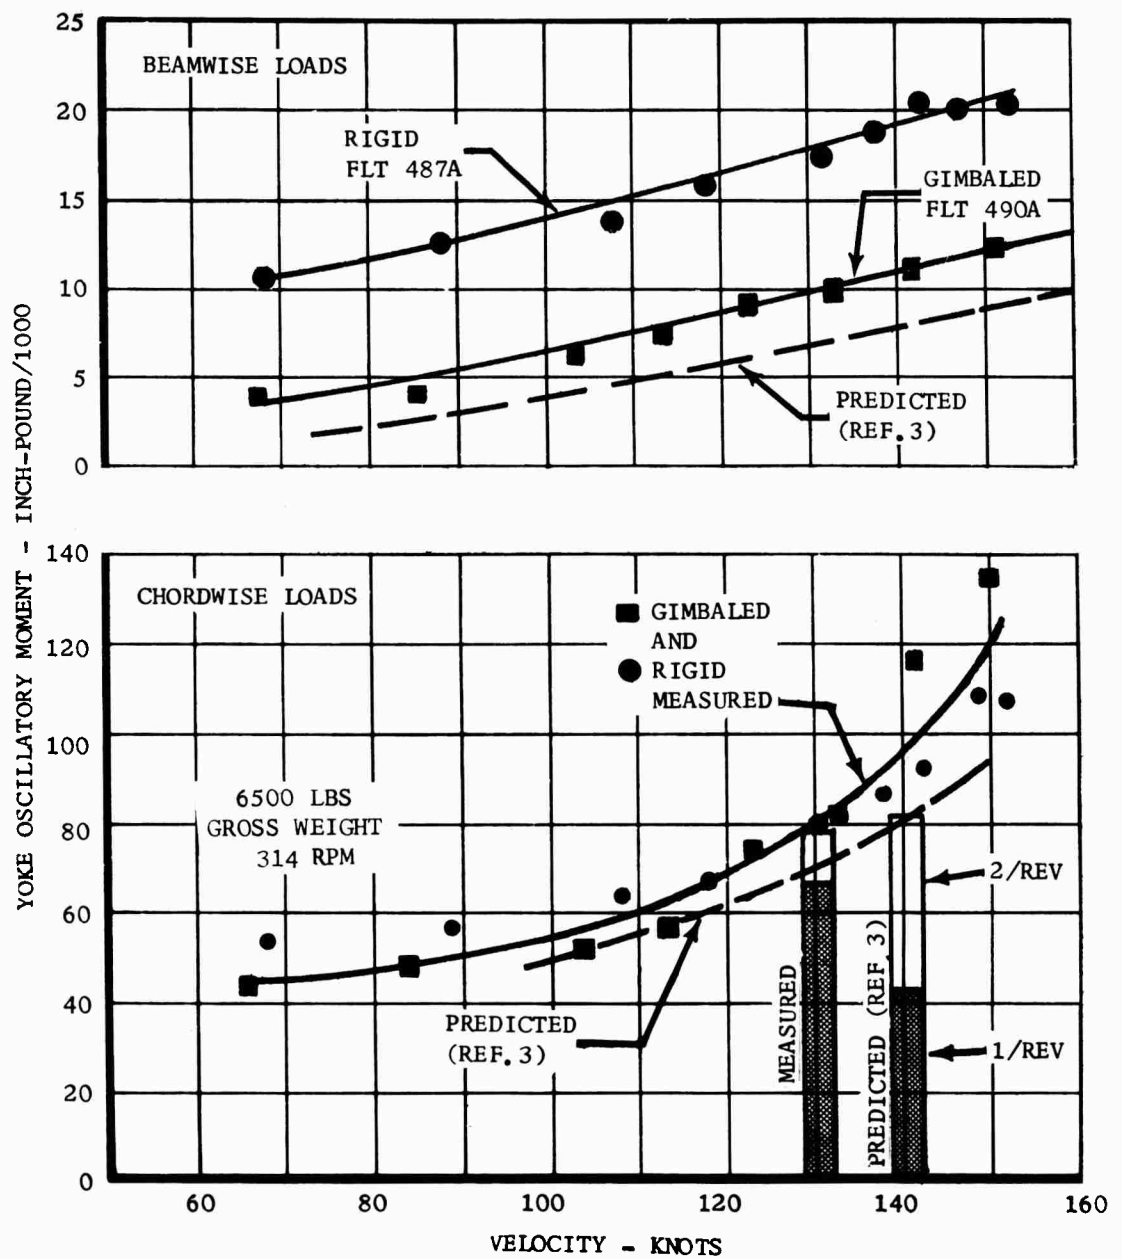
FIGURE 32 - MAIN-ROTOR LOADS, THREE-BLADED ROTOR.

The oscillatory beam and chord yoke loads for the three-bladed rotors are shown in Figure 32. The in-plane moments for the rigid and gimbaled rotor are the same. Although the total oscillatory chord load was correctly predicted, it was found that the one-per-rev component was underestimated and the two-per-rev component was overestimated. This also indicated on the figure. The oscillatory beam moments are correctly predicted, and are primarily three-per-rev for the three-bladed gimbaled rotor. For the rigid rotor, a one-per-rev component is added, which is caused by the steady hub moments due to the fuselage center-of-gravity location and the combined fuselage and elevator aerodynamic pitching moments about the hub.

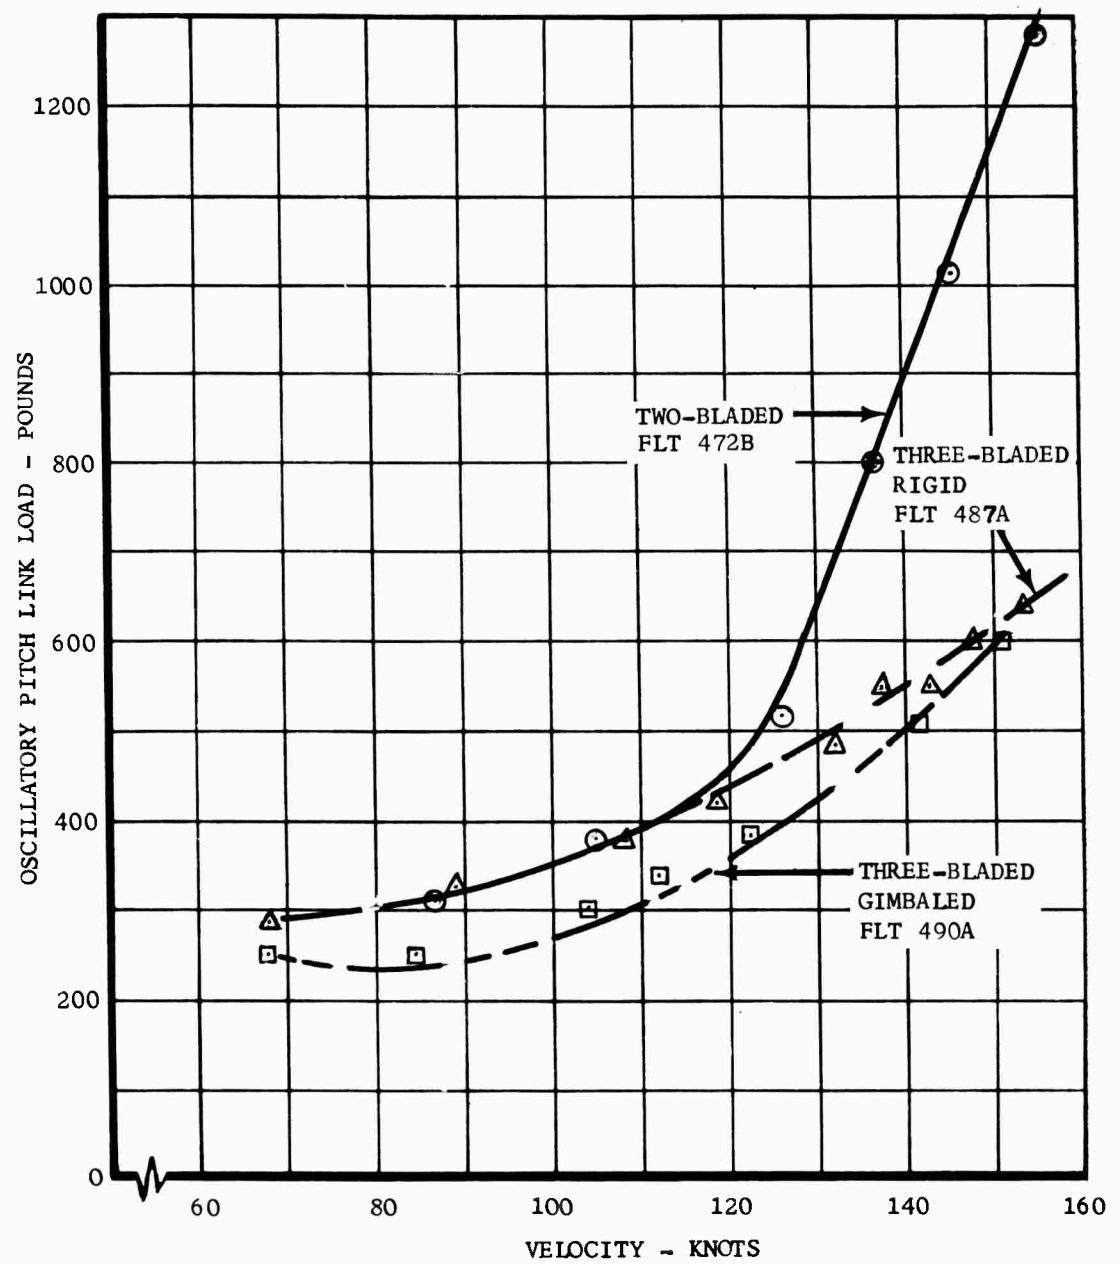
FIGURE 33- MAIN-ROTOR CONTROL LOADS.

A general comparison of the control system loads is shown below. Flight test data are given by Figure 33. At the time of the high-performance-helicopter design study (Reference 3), no attempts were made to predict control loads. Since then, methods have been developed to calculate these loads. Trends found experimentally during the high-performance-helicopter program and reported in the following discussion were confirmed

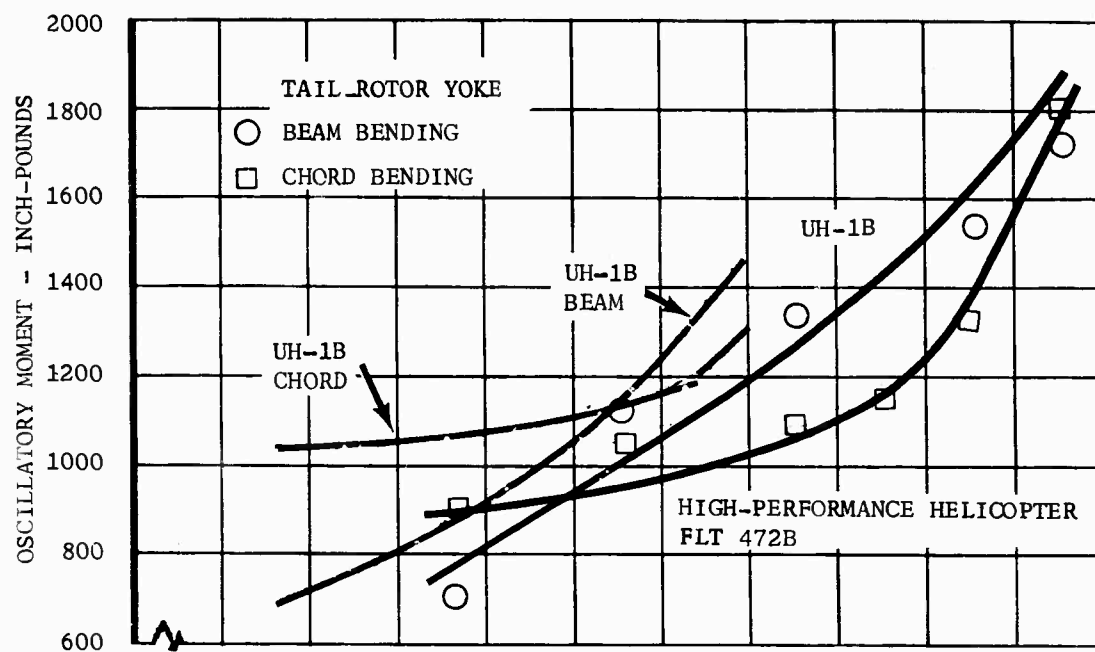
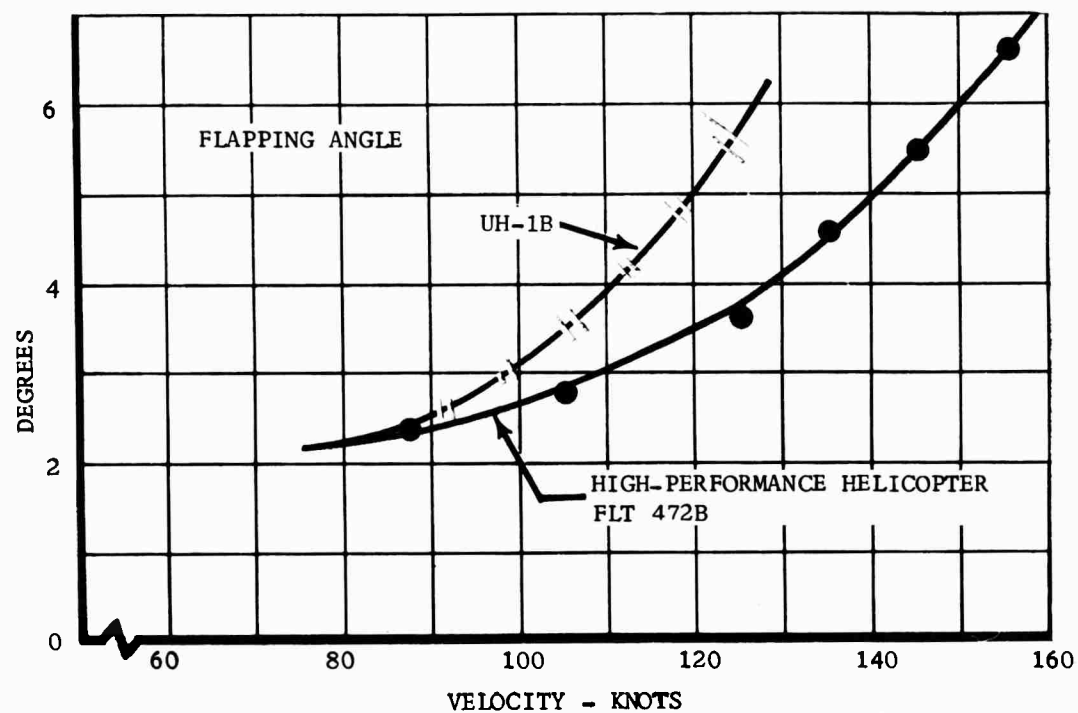
FIGURE 34 - TAIL-ROTOR LOADS AND FLAPPING ANGLES.

The tail-rotor loads and flapping as compared with the UH-1B are shown in Figure 34. At lower speeds, the reduction of loads is primarily the result of the reduced main-rotor power required for the test vehicle. At the higher speeds (130 knots and above), the effect on the cambered vertical fin becomes significant in unloading the tail rotor. It is estimated that the amount of unloading by the fin is about 50 per cent at the maximum forward velocity. At the initiation of the flight tests, the standard tail-rotor yoke was installed on the test vehicle. During the program, it was found that the endurance limit of the standard yoke was exceeded at high speeds. The standard yoke was replaced with a shot-peened yoke which has an endurance limit 27 per cent higher than the standard. With the new yoke, the loads remained within the endurance limit for all flight conditions.

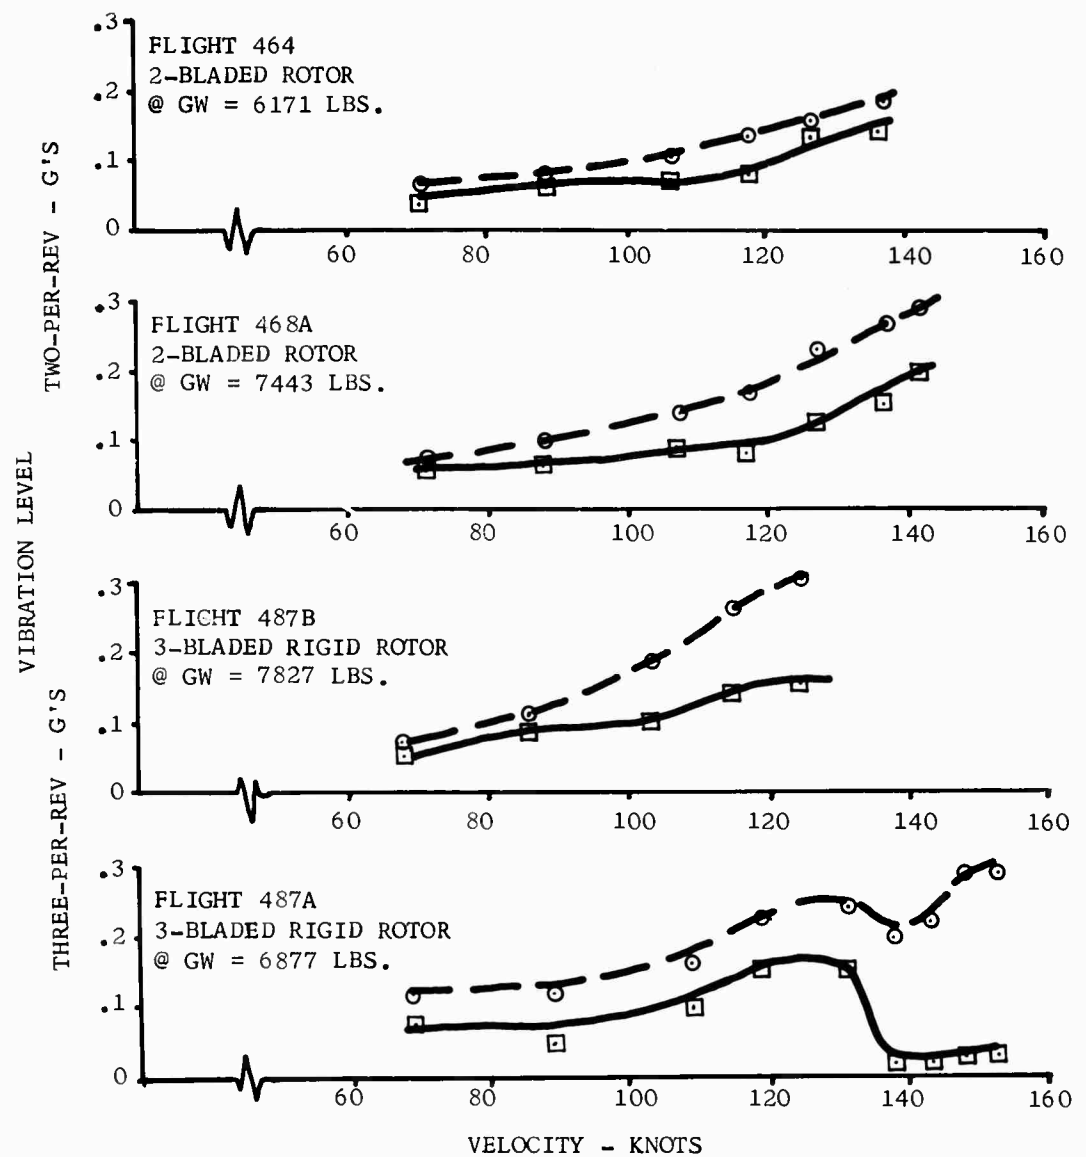
FIGURE 35 - MEASURED VIBRATION LEVELS

HU-1B aircraft, and consequently a direct comparison of the test vehicle and UH-1B vibration levels can be misleading. Although the test fuselage exhibits a higher response than the UH-1B, particularly at two-per-rev, it was found that the research vehicle could be flown up to 30 knots faster than the production machines before encountering the same vibration levels. Figure 35 shows the vibration level as a function of airspeed at the pilot and copilot stations for the two-bladed and the three-bladed rigid rotor configurations. The sudden reduction of pilot vibration at high speeds with the rigid three-bladed rotor is difficult to explain, but it could be caused by a change in interaction of rotor and control force excitations. Figure 36 shows the vibration characteristics of the three-bladed gimbaled rotor and illustrates the influence of changes in loading on the fuselage response. Note that the higher gross weight condition had lower vibration levels. The vertical cabin response to three-per-rev rotor forces as deduced from the measured shear load in the hub flexures indicates $\pm .25$ to $.3$ g per 1000 pounds oscillatory vertical force. This is approximately twice the value as determined by the shake tests conducted earlier, and indicates that other three-per-rev inputs such as oscillatory inplane shear loads, control system feedback, and downwash effects on the fuselage also are sources of cabin vibration.

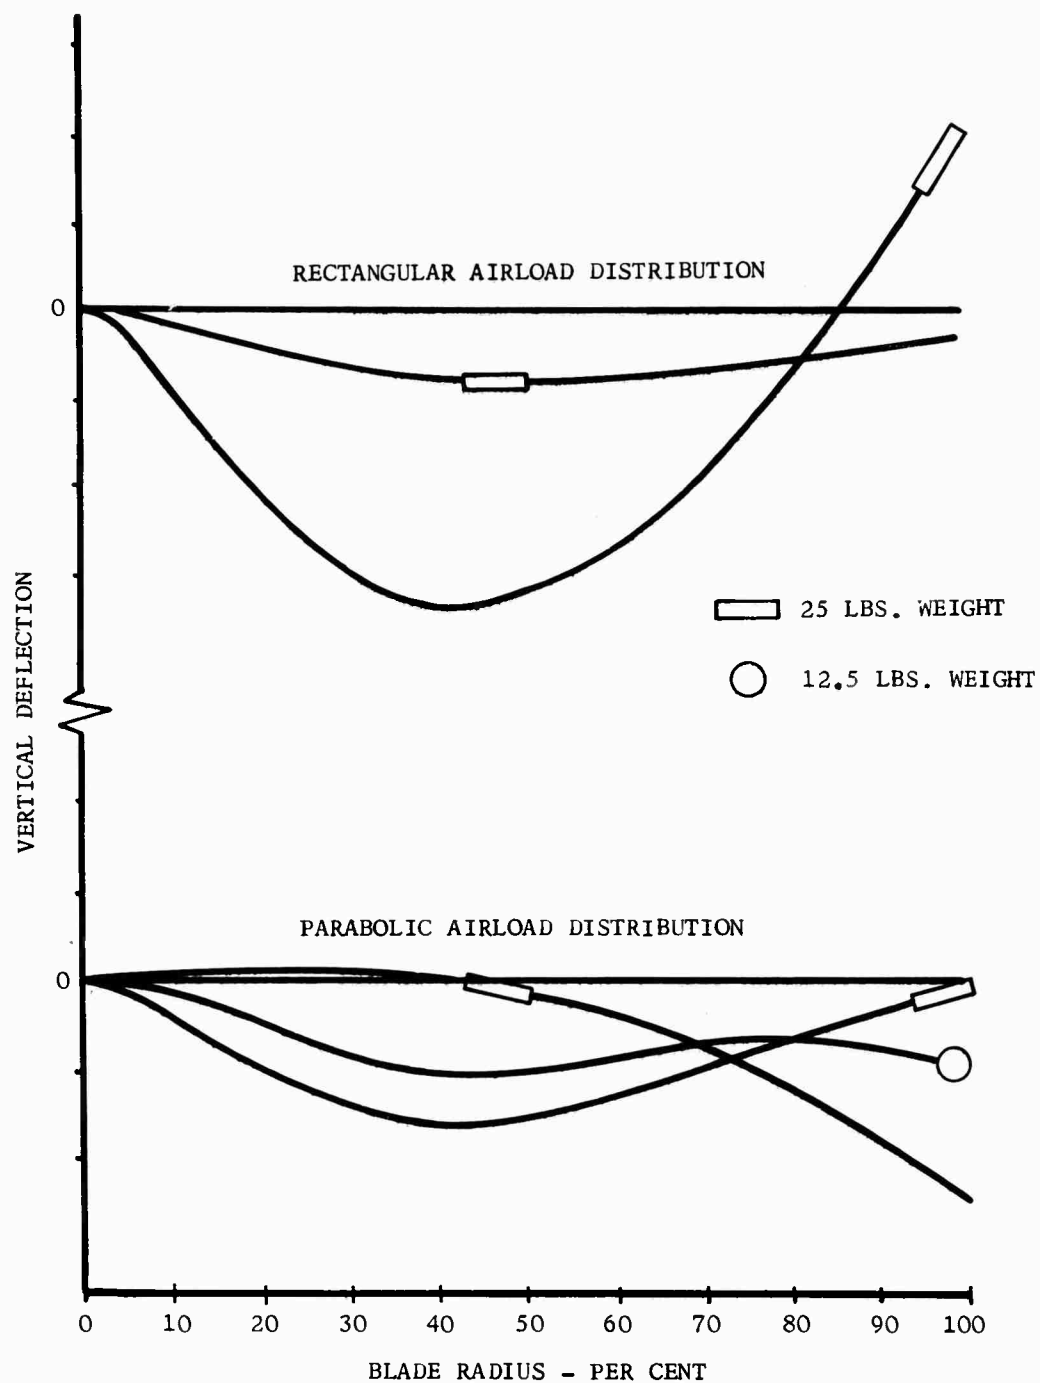
FIGURE 37 - BLADE RESPONSE TO 3/REV AIRLOADS AND INFLUENCE OF MASS DISTRIBUTION.

Figure 37 is an example of the results of the computer study, which indicated that blade bending near the hub is reduced by adding weight at midspan. The study evaluated both parabolic and rectangular air-load distribution. Although the blade deflection curves change with the air-load distribution, the midspan weight location appears most desirable. For both assumed distributions, the midspan location lowers the second mode beamwise frequency and minimizes the magnitude of the vertical hub shear due to the three-per-rev blade beam bending. The change in blade mass distribution also resulted in corresponding reductions in vibration and control loads.
